Montgomery County Fire and Rescue Service

POST INCIDENT ANALYSIS

**2nd Alarm Town House Fire
19326 Elderberry Terrace
Germantown, MD**

Incident Date: March 23, 2013

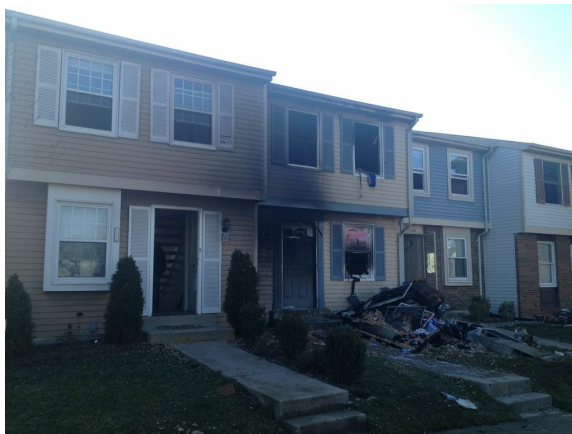
SIDE “A” – 2 stories second from the end of the row townhouse

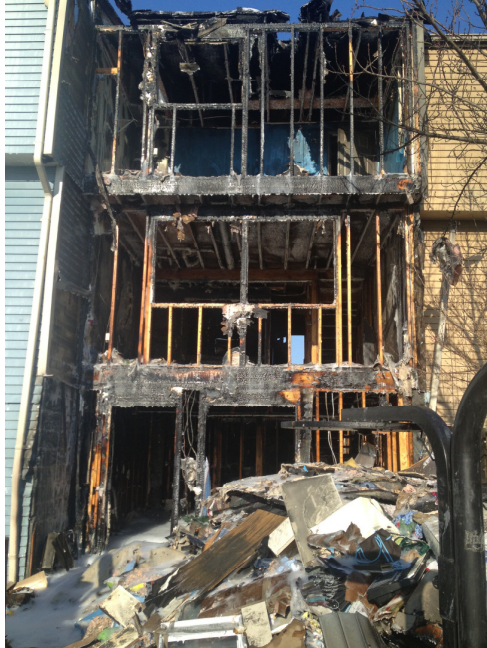
3 stories in the rear with a walk out basement. The walls that separated the “B” and “D” exposures were masonry block in the basement and triple hung drywall through the attic with no identified “poke-throughs”. The presence of masonry fire wall drastically decreased the lateral fire spread

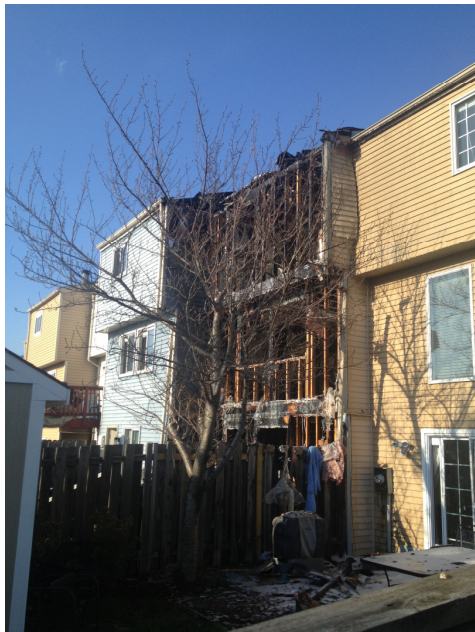
Offset of homes also effected fire spread. Fire was prevented from spreading to Exposure “B” because unit was set back and fully protected by Fire Wall. Exposure “D” was exposed to fire, bypassing firewall due to that unit extending past the fire wall.

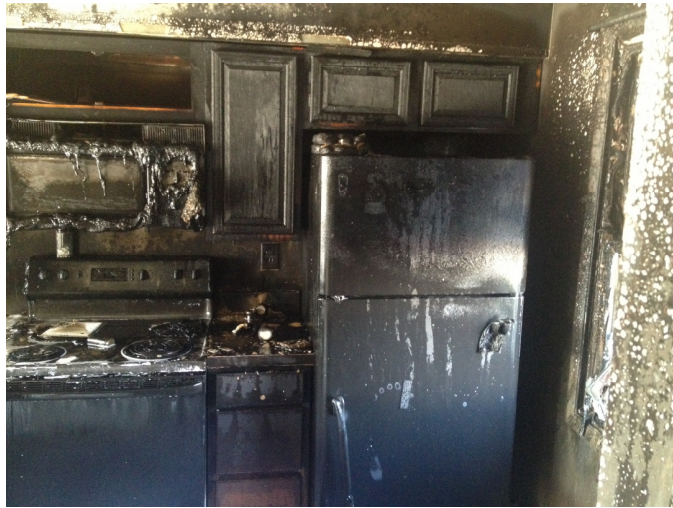
Damage to Kitchen – Side “A” Quadrent “A” - 1

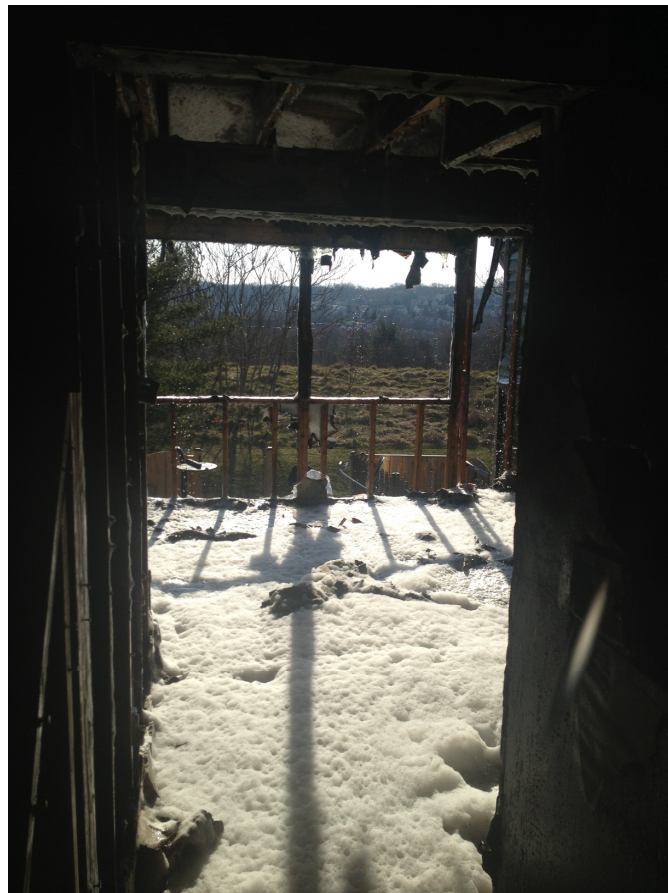
View from Front of TH toward and out Side “C”

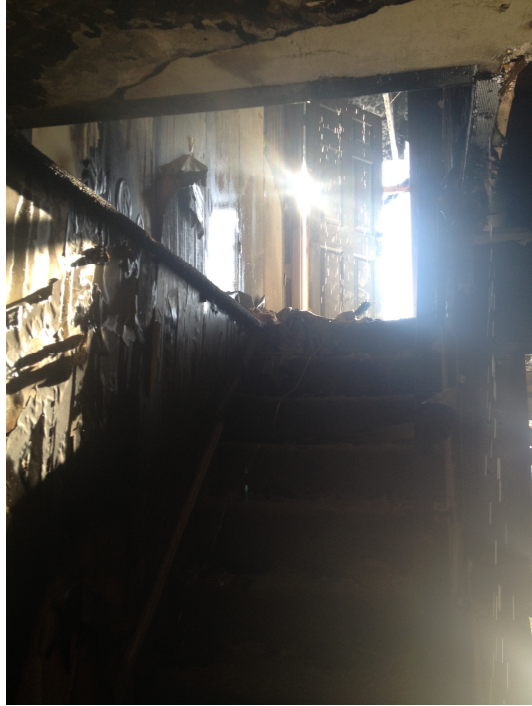
Stacked Stairs – Side “B” Quadrant A/B – View from 1st to 2nd Floor

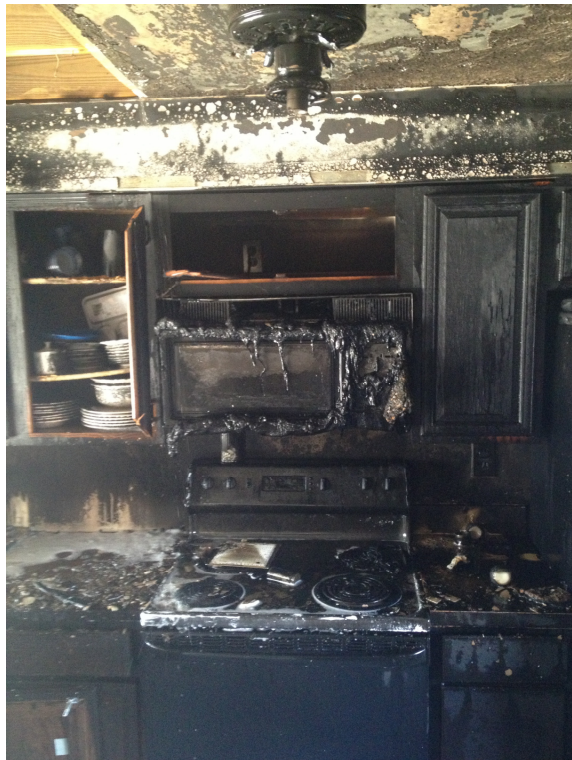
Damage to Kitchen – Side “A” Quadrant “A” - 2
